### PERFORMANCE TEST REPORT

SOLATUBE INTERNATIONAL, INC.

Report No.: 84491.01-301-47 Test Date: 06/11/08

**Project Summary:** Solatube International contracted Architectural Testing, Inc. to witness Impact testing at their facility on two 21" Tubular Daylight Devices (TDD). One 330 DS TDD (Photo No.1) and one 750DS TDD (Photo No.2) was tested in accordance with Federal OSHA Fall Protection Standard 1926.502(c) Safety Net Systems, 1926.502(b)(5) Screens, 1926.502(i) Covers, 1910.23(e)(8) Skylight Screens, and California State OSHA Fall Protection Code of Regulations, Title 8, Section 3212 (e)(1)(Skylight Screens). **The domes tested met the performance requirements as listed in the body of this report.**

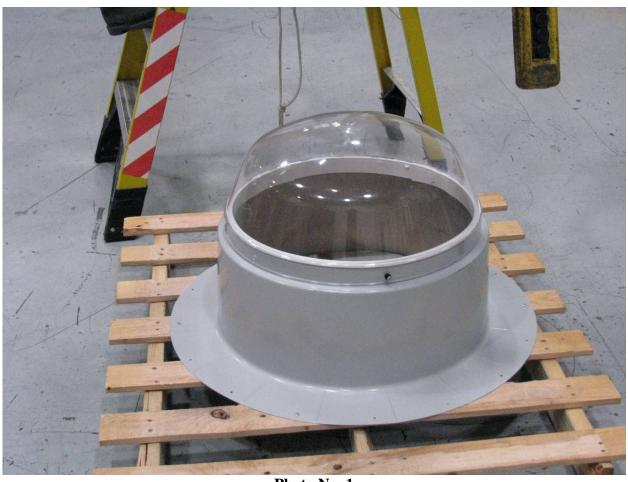
Photo No. 1 330 DS TDD

21''	21''
Series/Model	330DS-O	750DS-O
Dome Size	22-5/8"	23-7/8"
Dome Height	9-1/4"	13-1/4"
Dome Weight	68 oz	96 oz
Dome Thickness	0.168"	0.210"
Dome Material	Cyro	Cyro
Dome	Part # 509100	Part # 401930
Flashing	New - 11" Part # 200860	New - 11" Part # 200860
Dome Ring	Part # 400785	Part # 400785

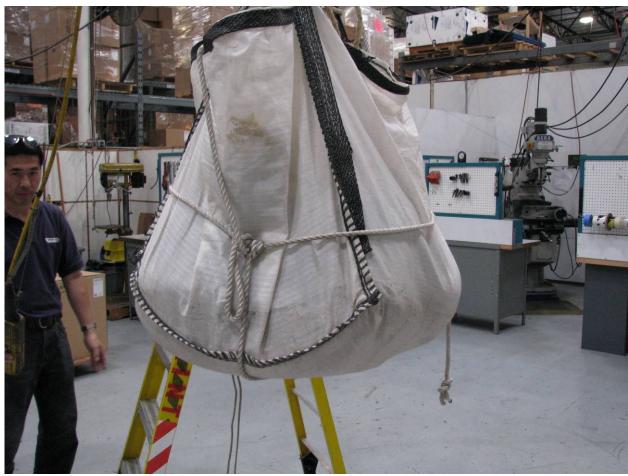
Photo No. 3 30" Diameter Sand Bag

**Test Equipment:** The equipment used to conduct these tests meets the requirements of the Federal Standard Fall Protection and California OSHA Standard Fall Protection. The 400 lbs. bag consisted of several sandbags bundled in a tarp and tied together with rope, measuring a total of 30" diameter. (See Photograph No.3) The actual weight of the bag (430 lbs.) was measured with a GSE Model 450 scale S/N 413955 and last calibrated 02-09-08.

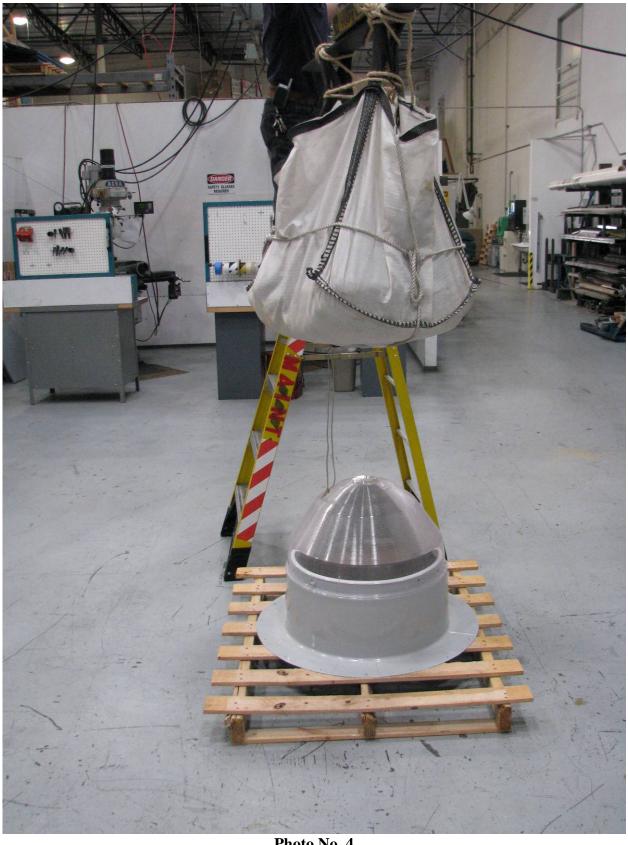
Photo No. 4 Sand bag at drop height

**Test Procedures:** Federal OSHA Fall Protection: Standard 1926.502(c) Safety Net Systems, and the California State OSHA Fall Protection Code of Regulations, Title 8, Section 3212 (e)(1) Skylight Screens. The 400 lb. (180 kg) bag of sand 30 inches (76 cm) in diameter was elevated 42 inches above the roof deck then dropped, without restraint (Photo No. 4), onto the top of each dome. (See Photos No. 5 and 6) The dome and flashing assembly was then inspected for failure.
